HEC-RAS ANALYSIS: RIVER L'ÄIRE, GENEVA, SWITZERLAND

Flood Risk Assessment and Bank Stabilization Strategies
for Sustainable River Management

Mesfin Hagos Tewolde [EUR ING, PE]

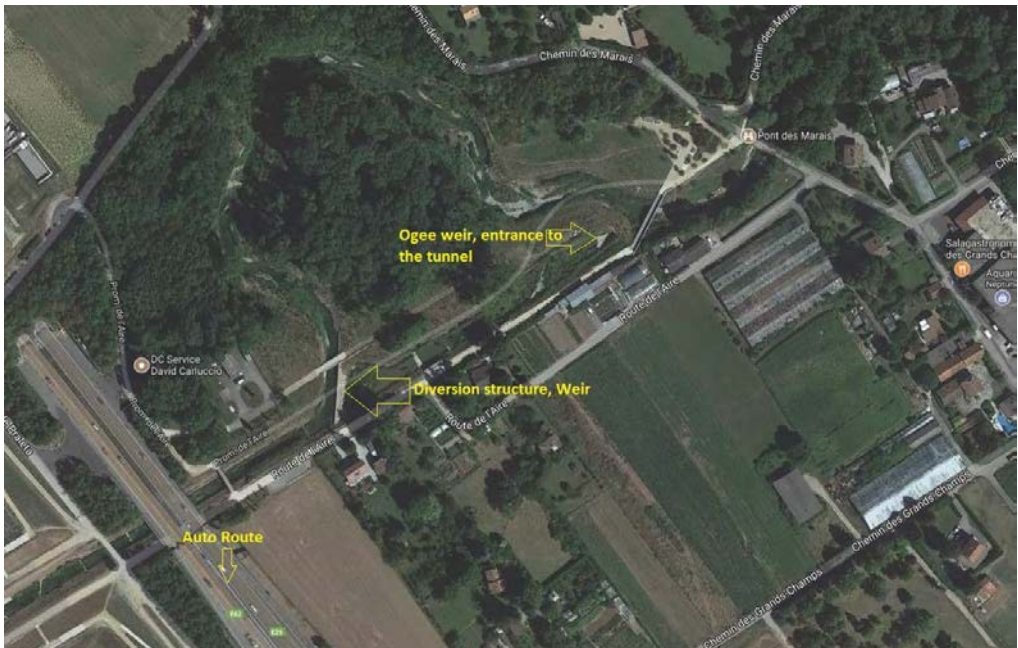
Figure 3 Newly constructed diversion structure and tunnel.

As the highest possible discharge that can be taken care of at the Pont Rouge (tunnel entrance) is 60 Cumec, lowering the discharge below 60 Cumec is essential. The new construction work of the diversion structure reduced effectively the amount of discharge at the Pont Rouge. The result of this HEC-RAS analysis has also demonstrated the same.

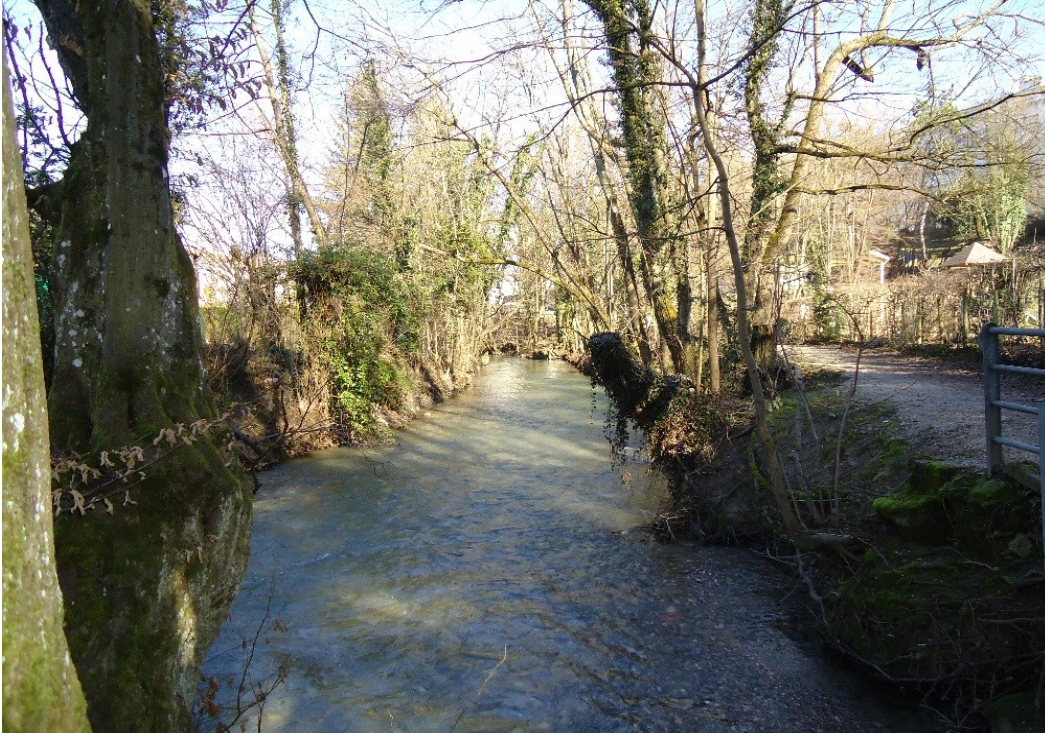
Figure 4 Vegetation covers around 2.8 km of the Pont-Rouge (photo taken on 4.03.2014).

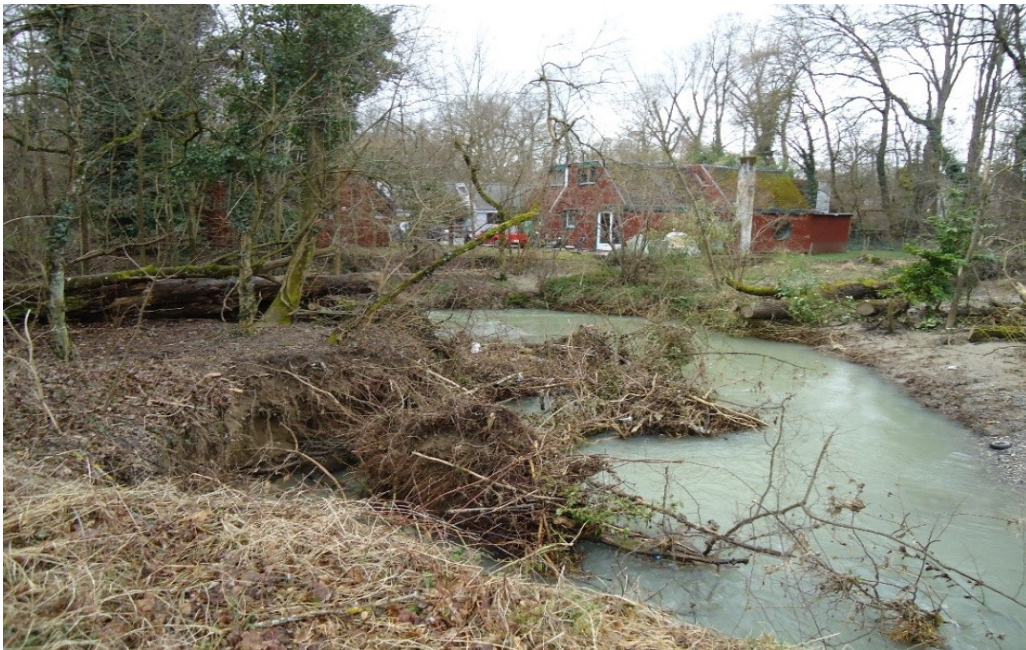
Figure 5 Eroded bank at around 4km upstream of the D/S end (Photo taken on 4.03.2014).

Along the River Aïre many stabilization measures exist. For instance, one can see biological or organic protection as a measure to protect further degradation of banks. Moreover, certain gabion protections exist. Nevertheless, there are still spots where bank stabilization is needed. As it is pointed out in Figures 5 and 6, river-bank curvatures are prone to erosion and require protection. Construction of levees, temporary or provisional flood storage basins, and sometimes elevating the village above the flood line are some of the precautions that need to be implemented to alleviate future potential mishaps.

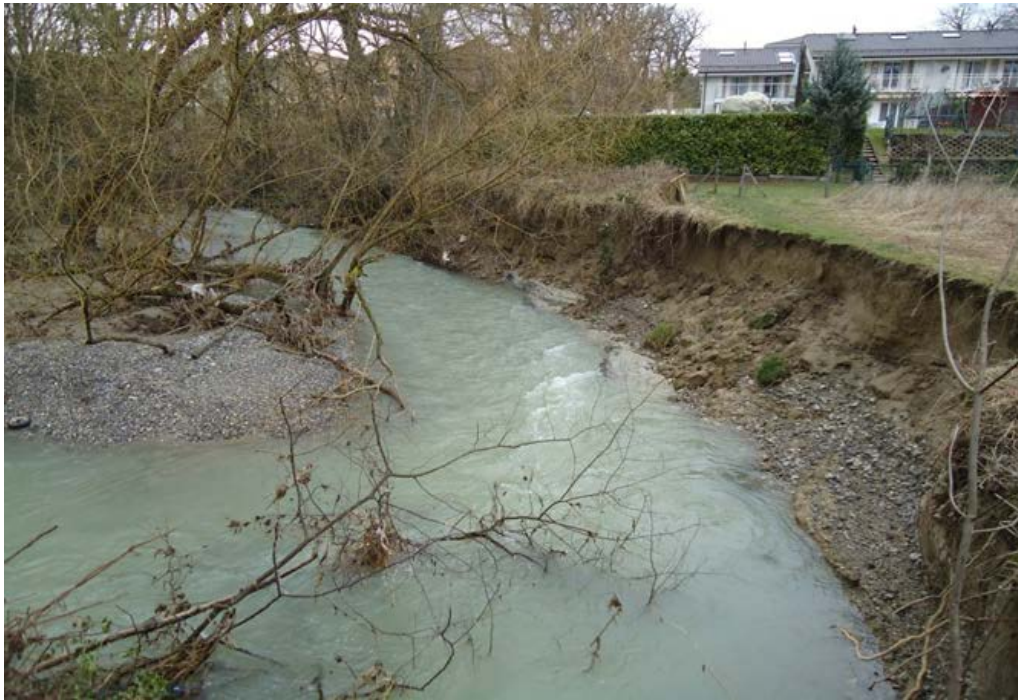
Figure 6 Unstable bank at around 4km of the D/S end (Photo taken on 4.03.2014).

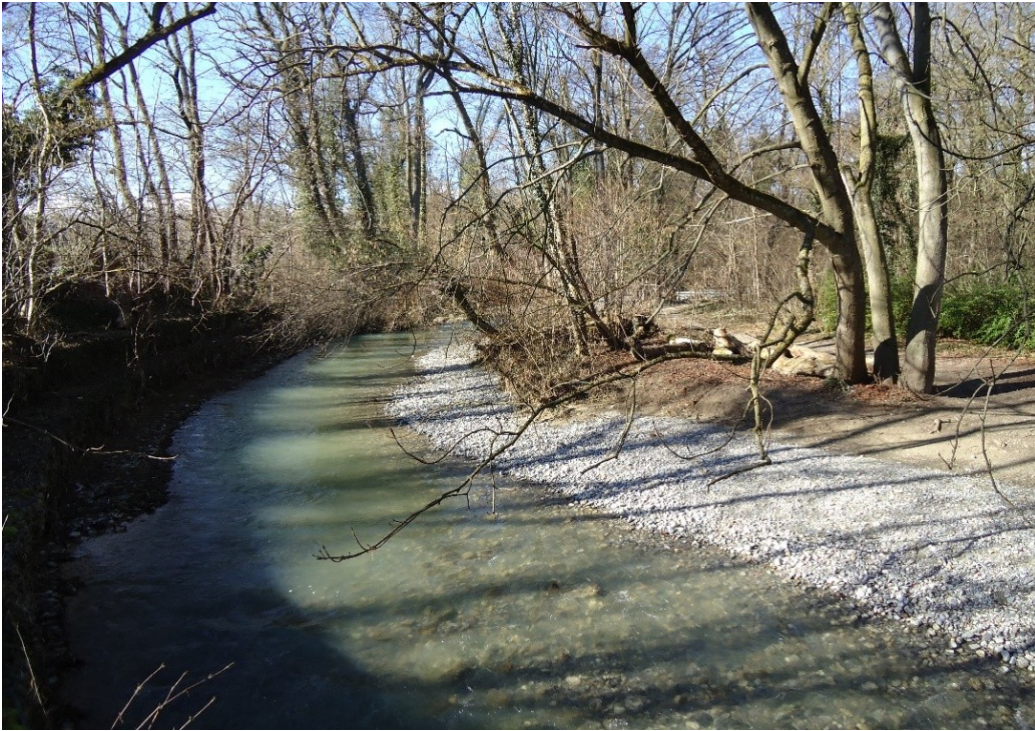
Figure 7 Cobbles along the main riverbed.

The analysis utilized cross-sectional and hydrological data, though the data source was not clearly specified. Corrections were applied where necessary to ensure model accuracy. The roughness coefficients were assumed to be 0.05 for riverbeds and 0.1 for banks, reflecting the presence of cobbles and vegetation. Flow measurements for four recurrence periods (Q10, Q30, Q100, and Q300) provided the basis for simulating hydraulic conditions. Flows for the given recurrence time periods are presented in Table 1.

Figures 7 and 8 indicate representation of the riverbed, the right and the left banks of the river.

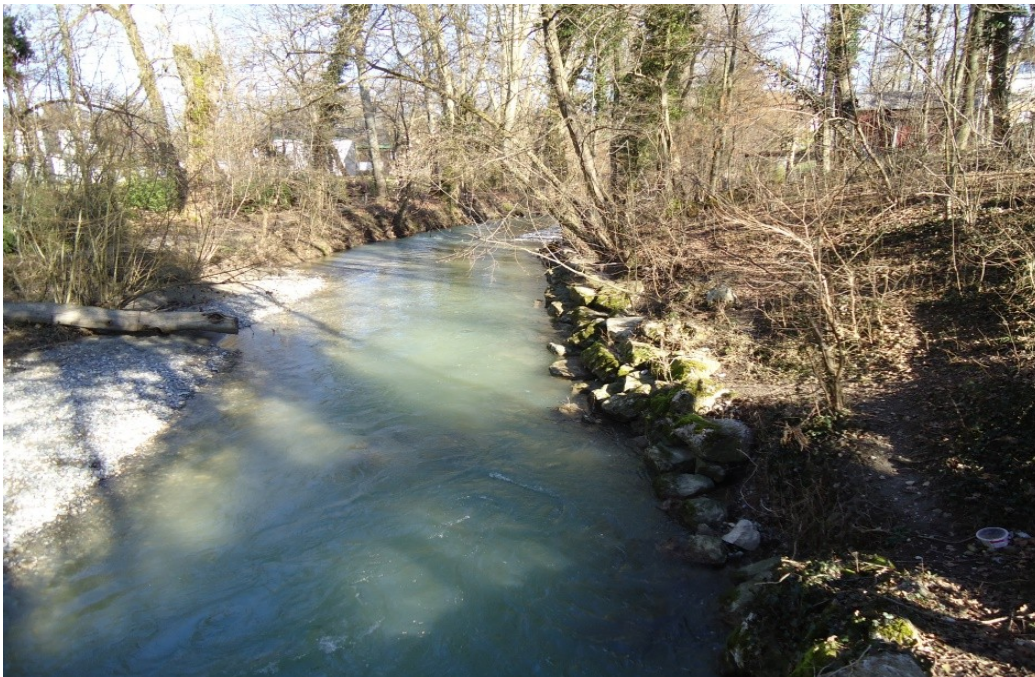
Figure 8 Vegetation covers along the river (represent 60-70%).

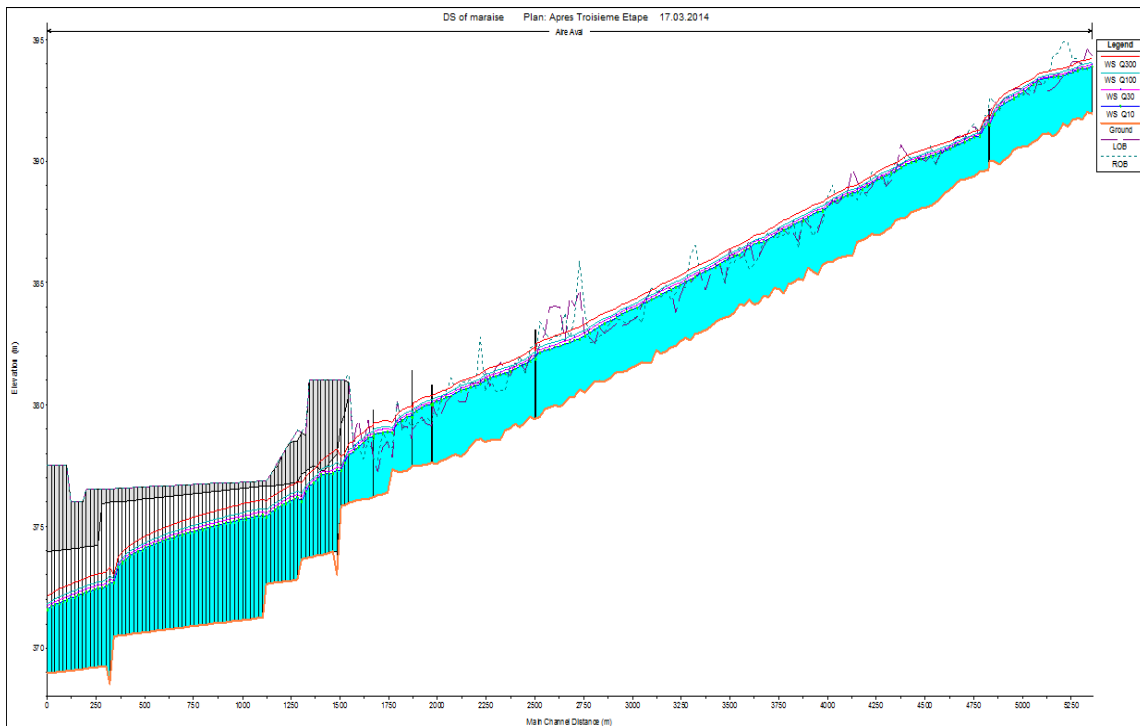
Figure 9 Longitudinal profile of the river for each return period.

The HEC-RAS simulations revealed flow velocities ranging from 0.63 to 3.95 m/s, with higher velocities causing significant erosion risks. At higher discharges, such as Q100 and Q300, inundation of adjacent areas becomes a serious concern. Protective measures like gabion walls, retaining structures, and temporary flood storage basins are essential to mitigate these risks.

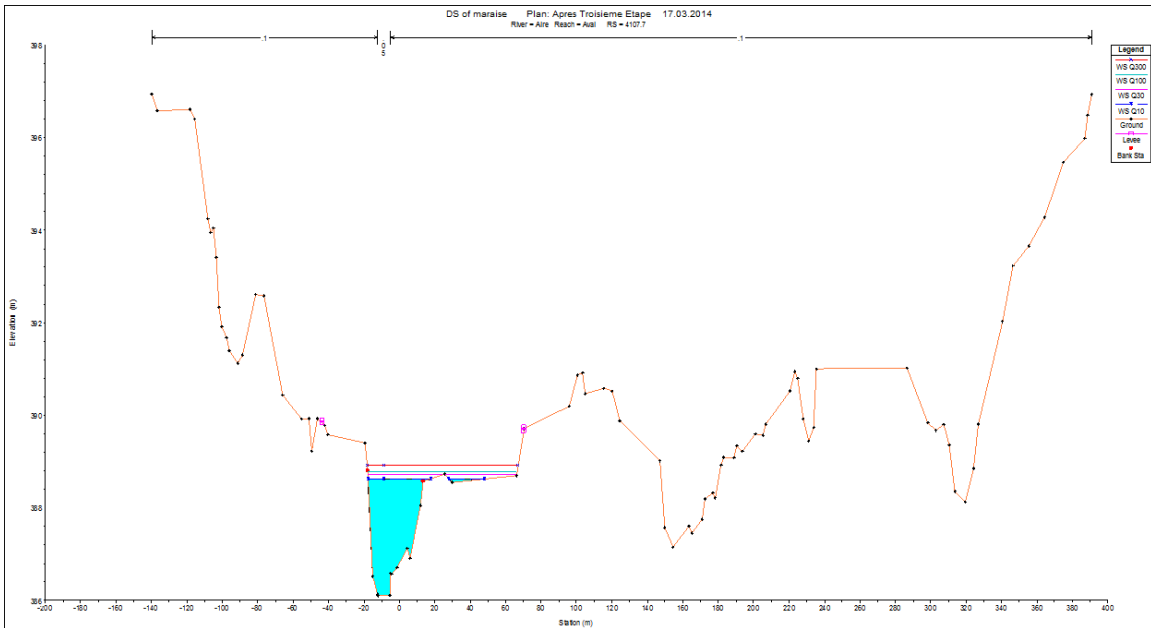
Figure 11 Cross-section at station 4107.7m.
